Manhole Inspection Summary

Manhole # S05YY1020MH

Insp Date: **9/7/06 8:44 AM**

Location Address: **5911 WINNER AVE**

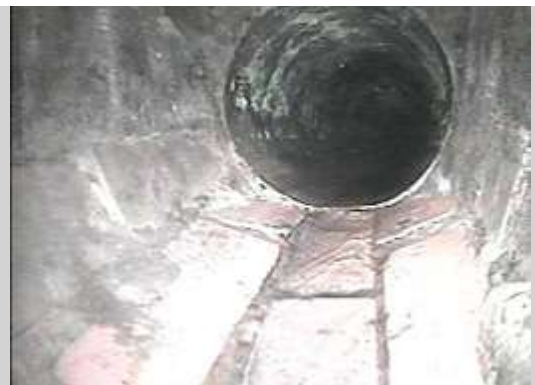
Pipe In @ 6 O'Clock

8 in. Circular Gravity Sewer

Pipe Material: **Clay** ☐ Pipe Lined

Infiltration: **None** Pipe Seal Cond: **Unknown**
